Natural Resources and Environmental Sciences Capstone Project

Marion County Lake Research Synthesis

Kansas State University

December 11th, 2020

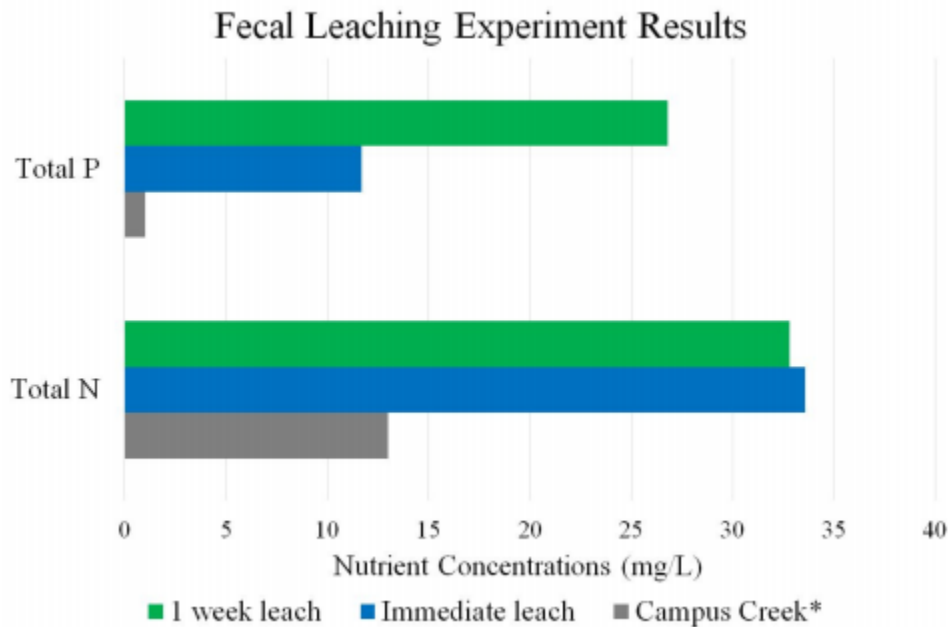
Fig 9: Results of the feces leaching experiment using water from the campus creek in Manhattan

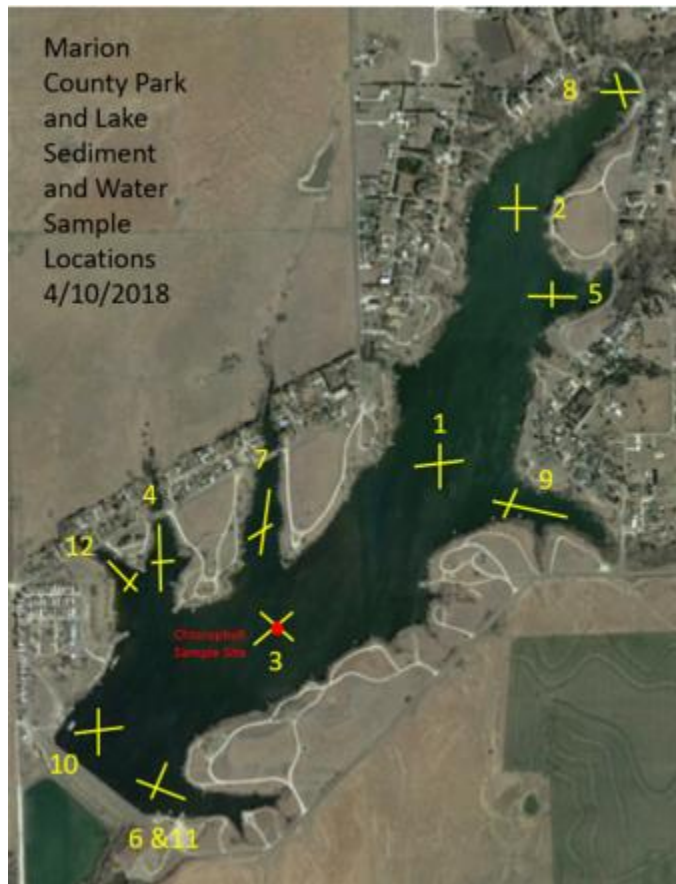
Fig 11: Marion County Sediment and Water Sample Locations

When taking the sediment samples, Allen and his team used a device called a gravimetric sediment sampler. Allen and his team would use the device to penetrate the surface sediment to collect a sediment core from the lake floor. By returning to this previous research project, the lake management team at Marion County should find that on the bottom of their paper is Appendices with detailed step by step instruction, to help recreate the experiments done by Allen and his team.

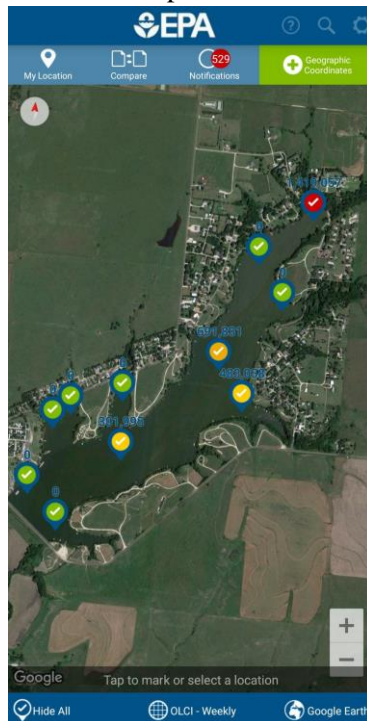
1. Opening: When opening the app, the user will have to find their watery location that they would like to monitor. The easiest way to find the location is to click the button on the bottom right (Google Earth) and change that to Google Maps. This will have the locations and parcels labeled.
2. After the location has been found, it is time to pick and choose locations around the water that the user would like to have monitored. It is as simple as clicking on the lake.
3. Once the locations have been placed like the image below, CyAN will remember these points and update regularly to alarm the user if one of the points in the lake is too high.

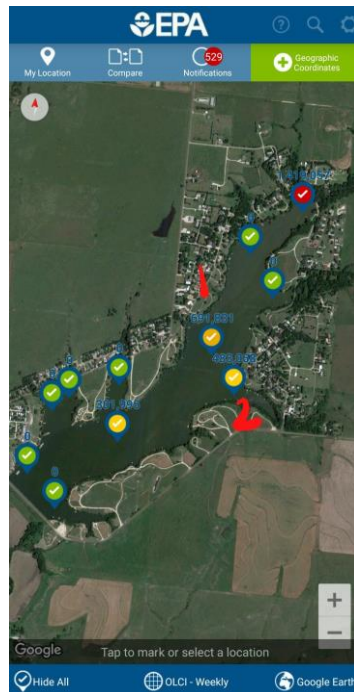
- For this demonstration this project will be comparing these two locations in the image below. Sites 1 and 2.

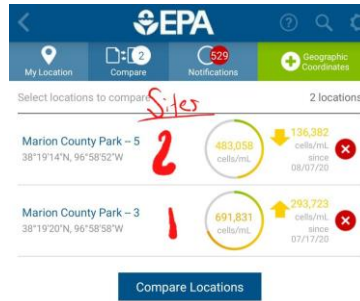
- Now that you have your sites selected and ready to compare, you will click the button on the top that says 'Compare'. After clicking that tab you should see a screen like in the image below.

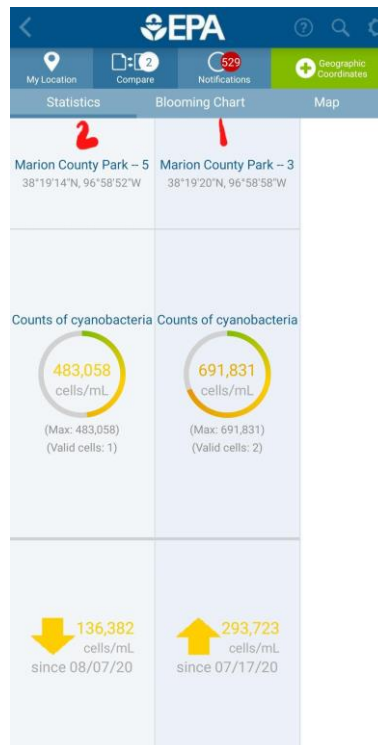
- From here you can click the compare locations button beneath the sites that you are wanting to compare. The first tab that you will be able to see is the 'Statistics' tab. This shows the differing stats between all locations selected. It should look as follows.

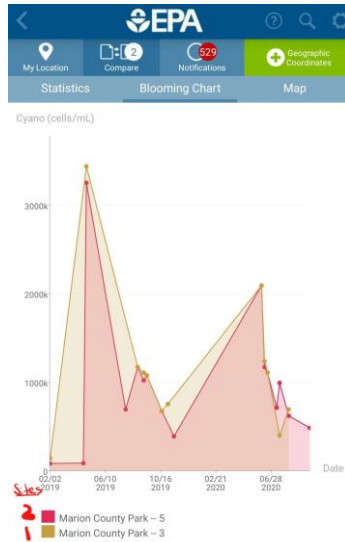
8. The next tab to the right of the statistics tab is called 'Blooming Chart' and when you click it, it should take you to a graph of your selected sites throughout given dates of recorded CyanoBacteria (HAB). It should look like the image below.

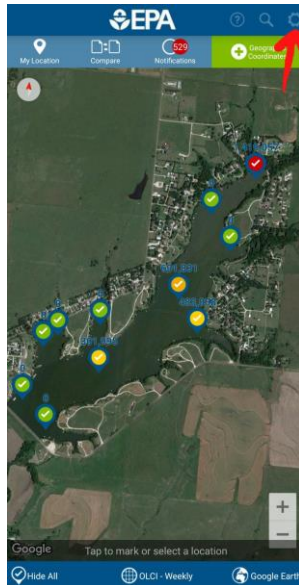
9. The next tab is the 'Map' tab and all this does is take you to show you where your locations that you selected to compare are.
10. Tap the left pointing arrow in the top left corner to go back to where you put your selected sites at.
11. In the top right section of the app there is a settings cogwheel that allows the users to change the variables of how low, medium, and high the concentrations are. The cogwheel is shown in the image below.
