MBACI Monitoring Set-Up for Tallgrass
Prairie Restoration on Kansas State
University Campus

Natural Resources and Environmental Sciences (NRES) Capstone

Spring 2022

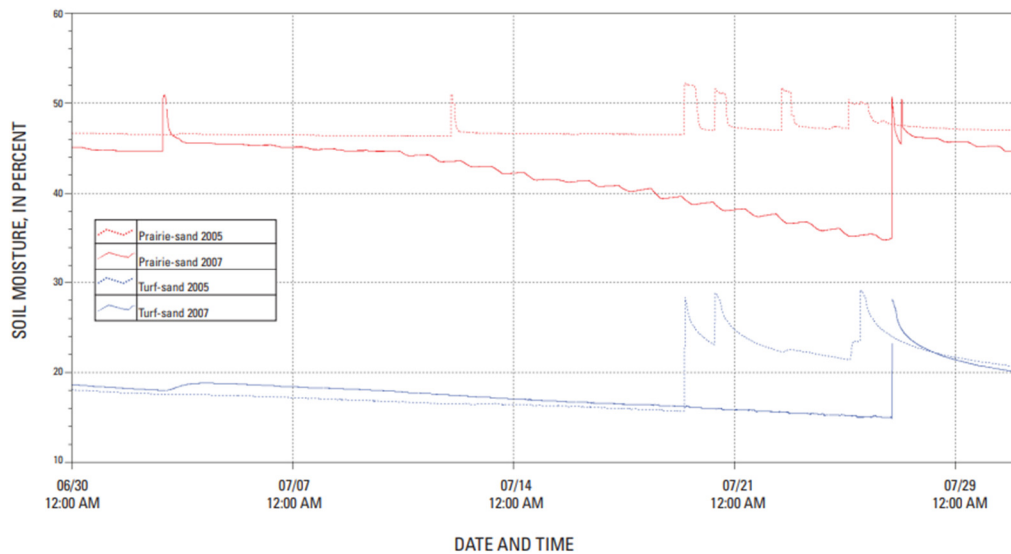
Figure 1: Differences in soil moisture percentage between turf and prairie rain gardens.

The moisture levels of the prairie grasses were taken at 2.6 feet under the grounds surface. The turf grass sample was taken 1.6 feet below the surface (Selbig & Balster 2010).

In addition to riparian zone rehabilitation, the conversion of the grasses from cool-season, non-native turfgrass to native tallgrass prairies species also carries benefits. Previous studies have found that runoff reductions can be greatly improved by using natural vegetation instead of manicured turf grasses (Selbig & Balster 2010). One study compared infiltration rates between two rain gardens, one with native prairie grasses and one with turf grasses. The research found that the prairie rain gardens had an average infiltration rate of 6.50 in/hr., while the turfgrass grass plot had an average rate of 3 in/hr. The researchers attribute this improvement in infiltration due to depth and density of prairie grass roots, extending deeper into the ground and creating more pores and fissures that soak up more water and at a faster rate than turfgrass (Selbig & Balster 2010). Figure 1 shows soil moisture levels of the two plots, with the prairie rain garden having a higher overall soil moisture through time than the turfgrass rain garden.

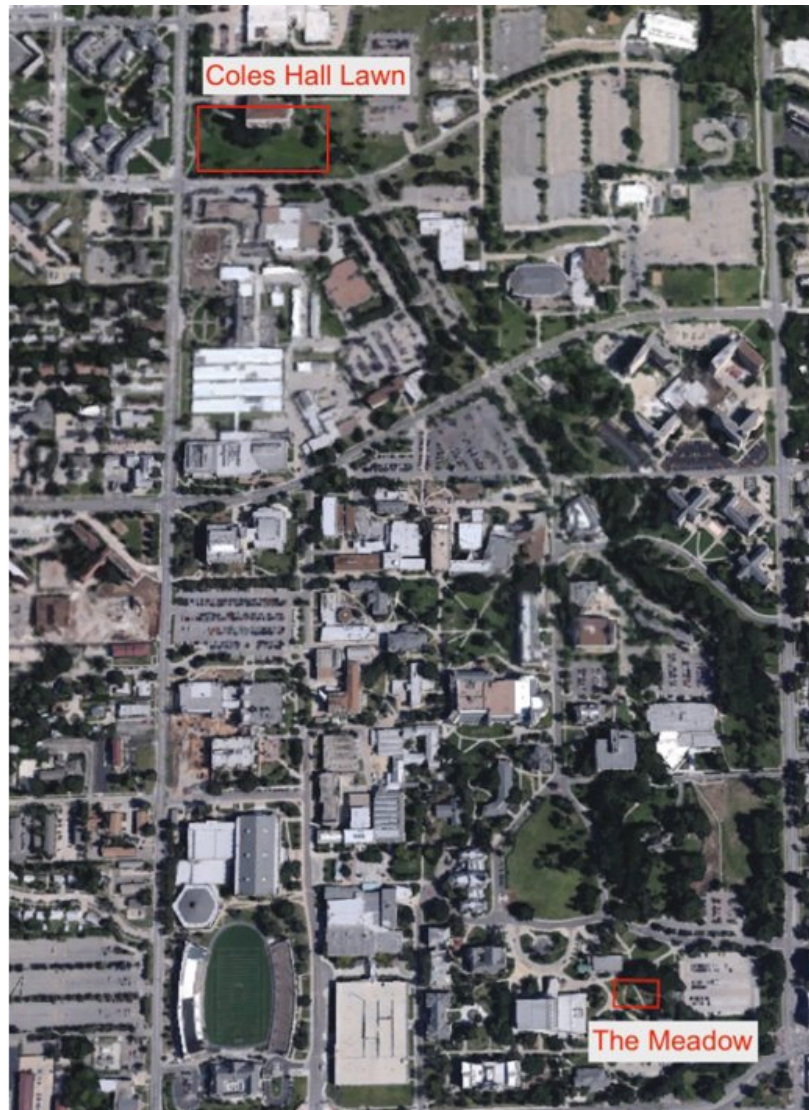
Image 2: the location of the impact site (Coles Hall), and the control site at The Meadow.

Coles Hall is currently inhabited mainly by turfgrass species, as well as a few trees. The drainage area is .25 square miles (Figure 2, below), and the area has a 5% slope. The main soil type for the impact site is 4050, Ivan and Kennebec silt loams, occasionally flooded, and is depicted below in Figure 3. The impact site on campus is mowed once a year (LARCP, personal communication, 2022). The collection method of these characteristics will be discussed further in the following section.

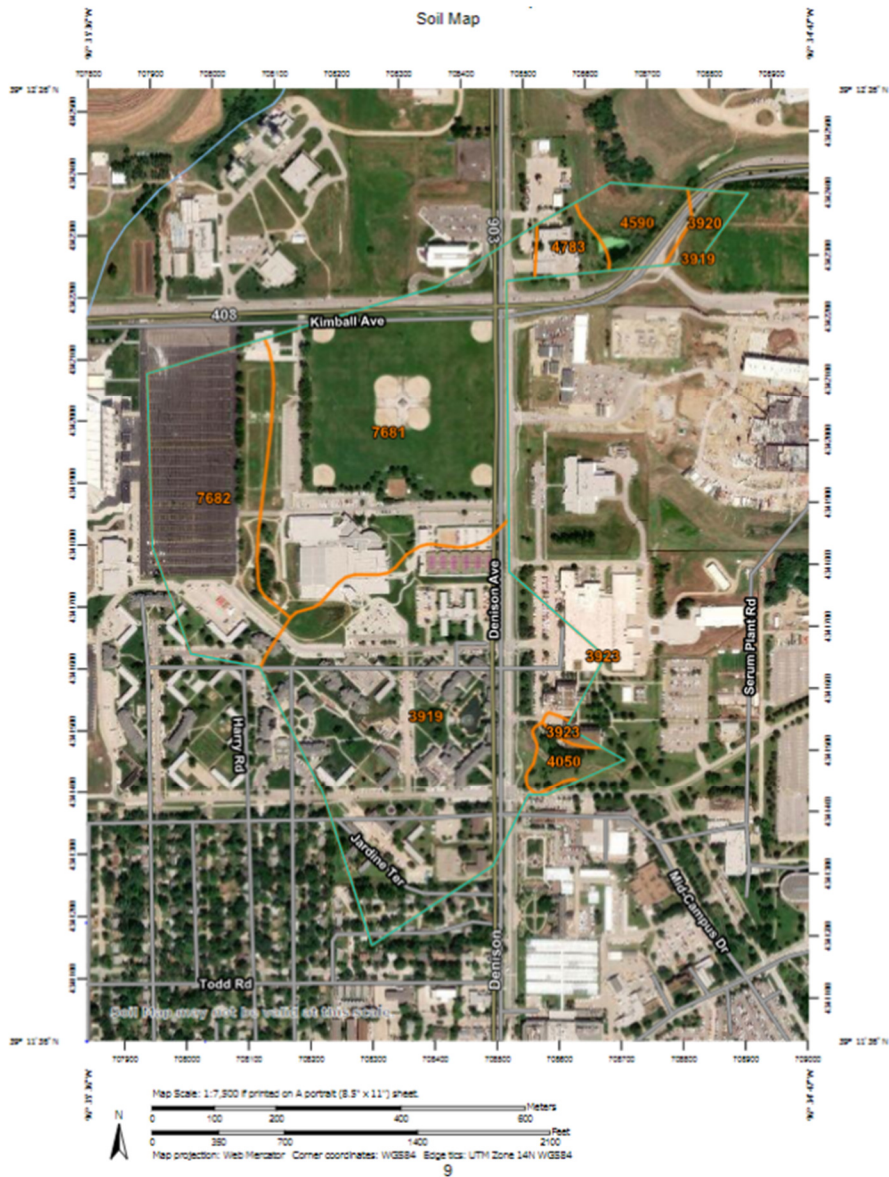
Figure 3: Web Soil Survey map for Coles Hall watershed.

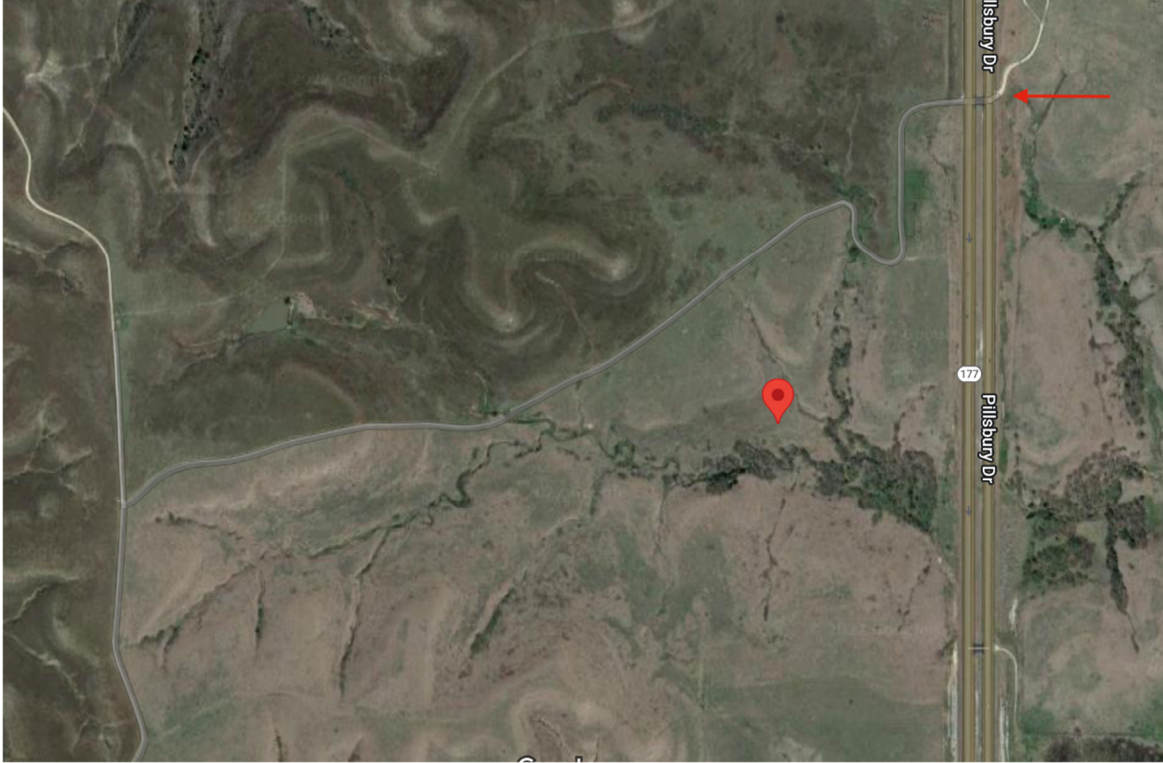
Image 3: depiction of road access to Konza Prairie control site.

provide similar disturbances. Although the Konza site is burned, it is minimal, being every 4 years and Coles Hall has the potential to undergo burning in the future if it is permitted. “The native area is cut down to the ground in early spring and has little maintenance throughout the year except for some weeding. There is a plan to possibly burn this area this spring if it is allowed” (Robinson, personal communication, April 14, 2022). The 2-, 5-, 10-, 25-, and 100-year high flow events were extremely close in value between the impact and Konza site providing similar hydrology (Table 2). Table 3 depicts the TR-55 method results for the Coles Hall impact site. In addition, this site includes road access which will allow future groups and easier way to access this location to collect data (Image 3, below).
