# Northview Pond Remediation

Prepared by:  
Chelsea Fleming  
Samantha Grieger  
Gary Koons  
Kristen Jones  
Tyler Peterson  
Nathan Tolle  
Ben Williams

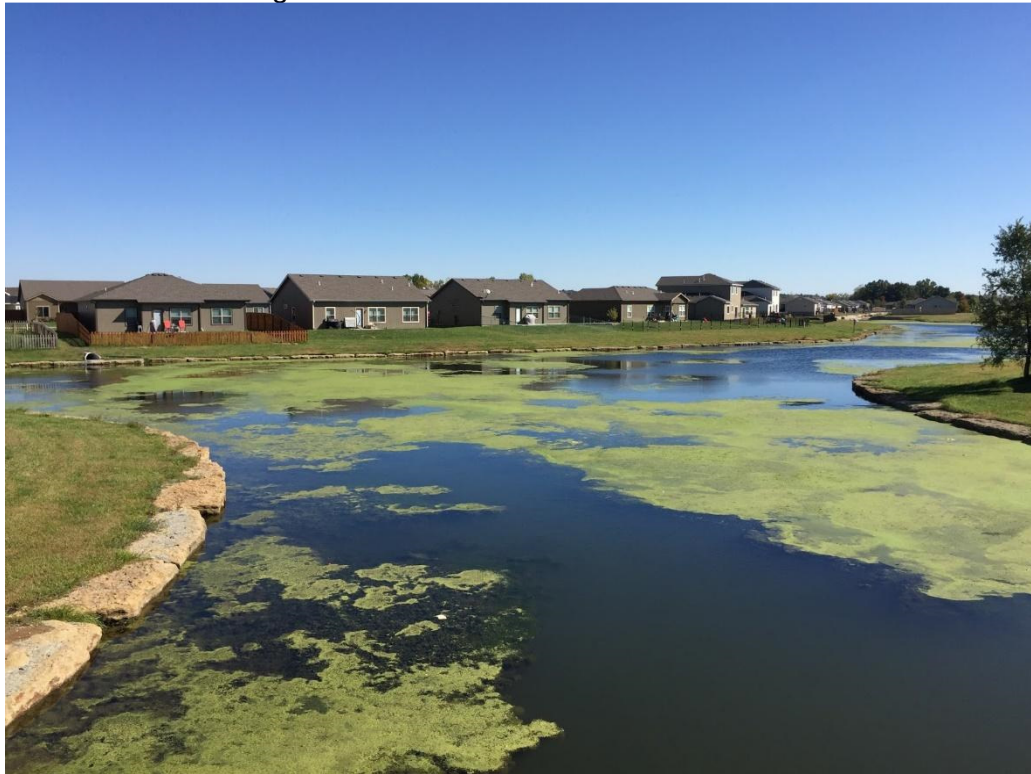
Figure 1: Northview Pond in October 2017

Figure 1 shows the macrophyte bloom that has taken over the pond resulting in poor aesthetics and a displeased HOA.

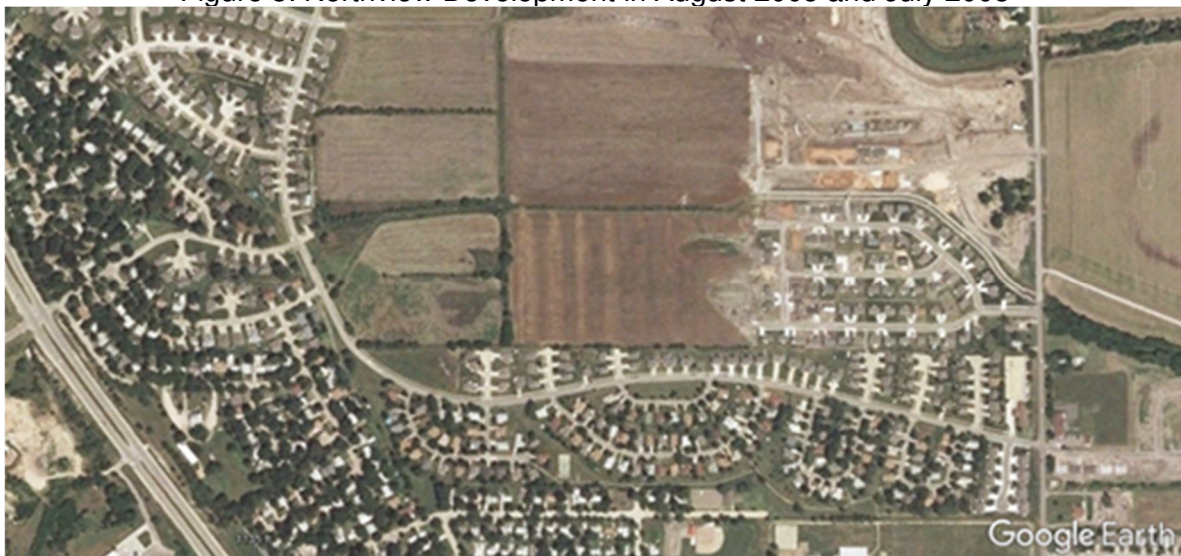
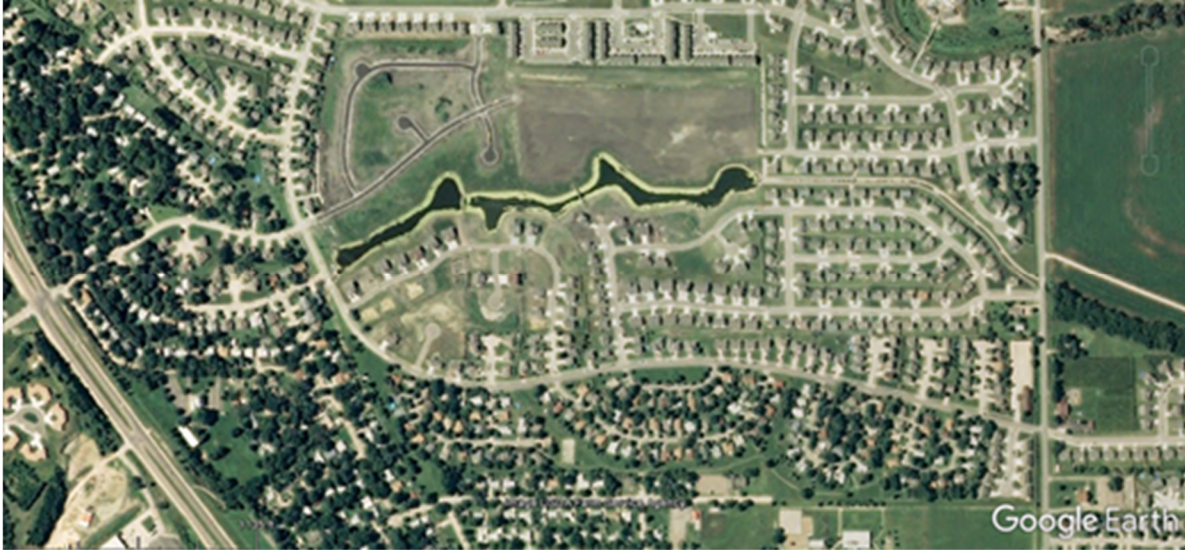
Figure 3: Northview Development in August 2005 and July 2008

Figure 3 shows an aerial viewpoint of the Northview Neighborhood development in August 2005 (above) and July 2008 (below) (Google Earth).

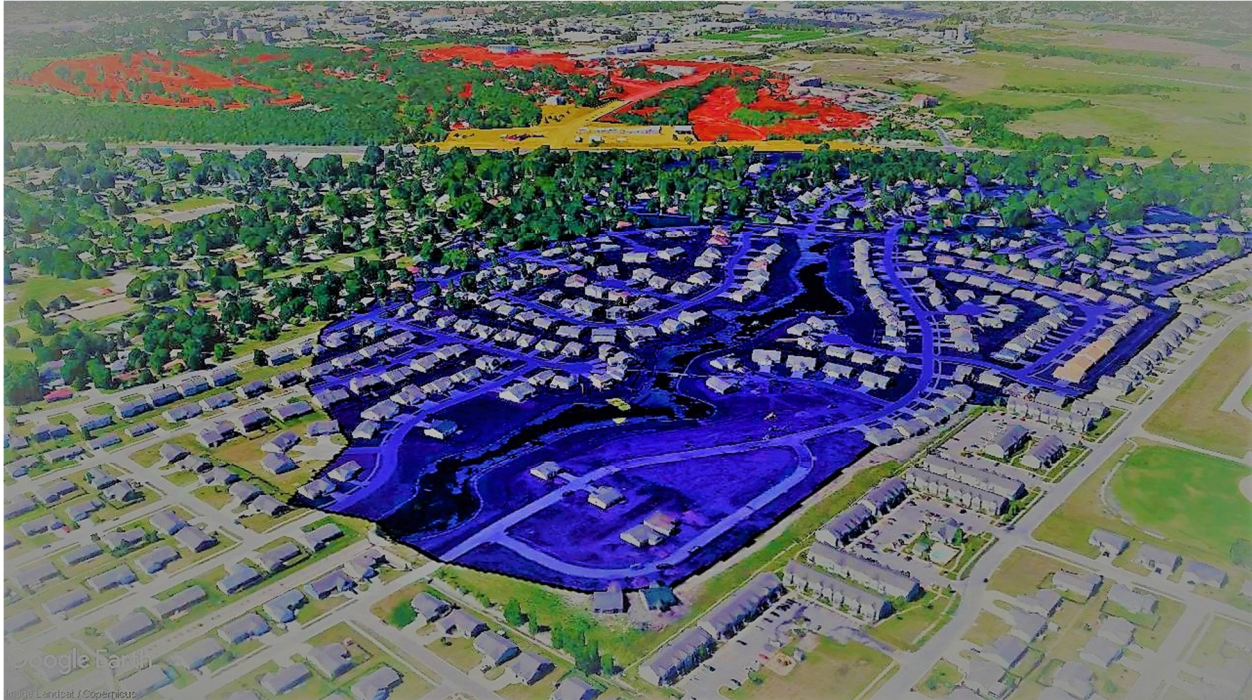
Figure 5: Northview Development in August 2014.

Figure 5 shows the Northview development from a viewpoint northeast of the neighborhood in August 2014 with the watershed reaches overlaid (Google Earth).

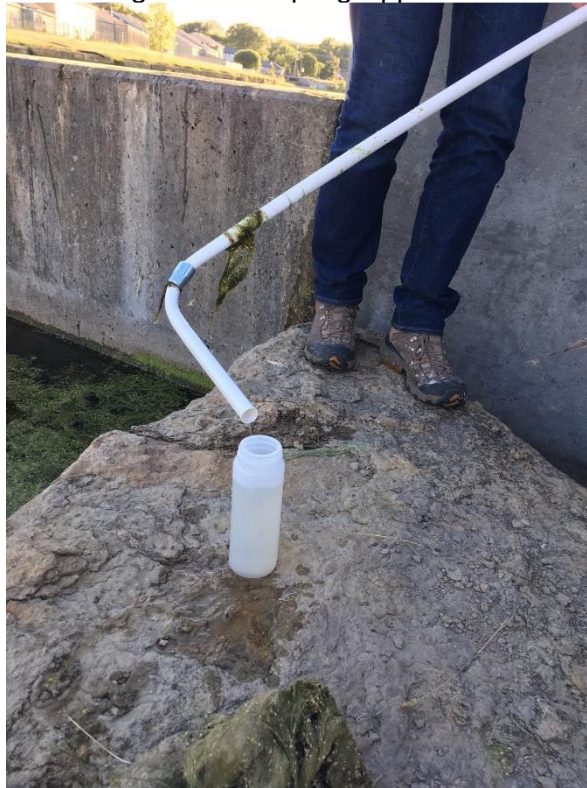
Figure 7: Sampling Apparatus

A 6-foot-long pipe fitted with elbow was used to extract the samples, which were then poured into 500 mL plastic bottles. The extraction apparatus is shown in the figure below.

Figure 7 shows the sampling mechanism used.

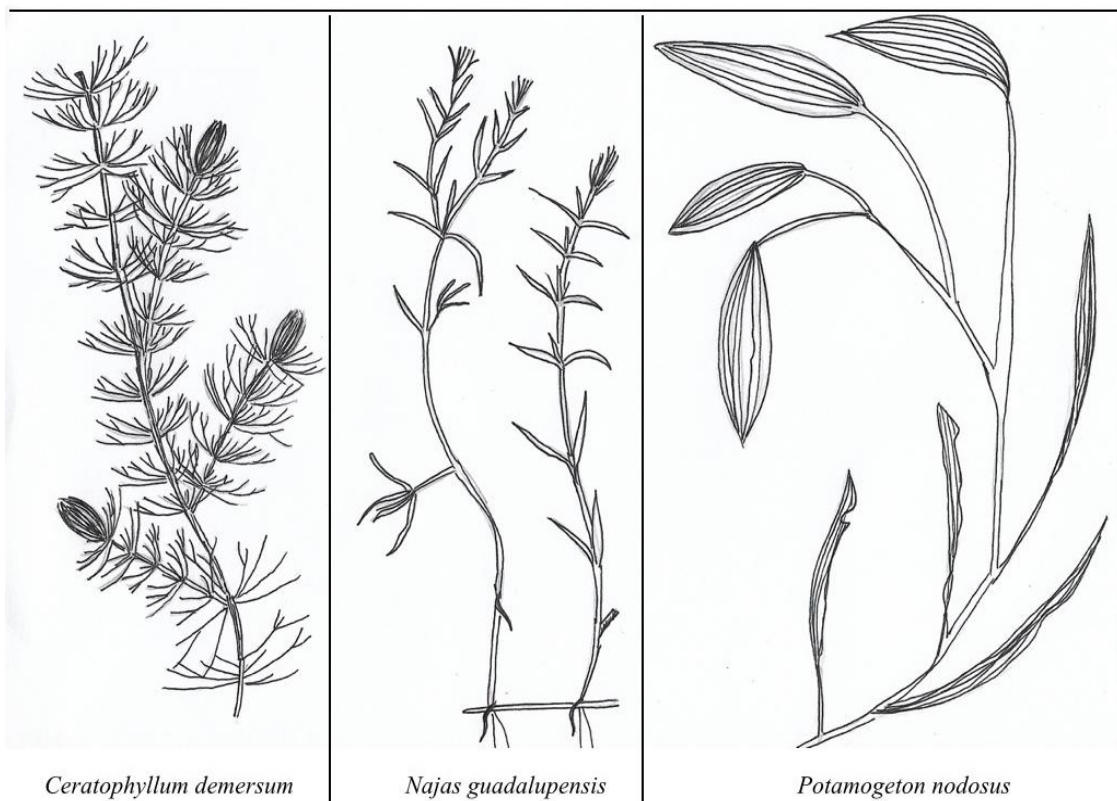
Figure 11: Three Major Submerged Aquatic Plants of Northview Pond

The plant identification found three major submerged macrophytes. These plants all seemed to be voluntarily established without human introduction. Illustrations of these are shown in Figure 11 below. The most abundant plants in Northview Pond were *Ceratophyllum demersum* (Figure 11A), *Najas guadalupensis* (Figure 11B), and *Potamogeton nodosus* (Figure 11C). All are native. *Ceratophyllum* (coontail) is a hornwort, and submerged perennial herb. It is rootless and free-floating. Coontail leaves are toothed, fan-shaped and arranged in whorls on the stem. *Najas* (common water nymph, southern naiad) is an annual, fully submerged rooted plant with extensive branching and thin leaves. Very fine teeth can be found on its leaves, which are usually a dark green color. American pondweed (*Potamogeton*) has floating and submerged leaves. Its floating leaves are oval shaped with parallel vein pattern and long petioles. Its submerged leaves are less abundant, almost transparent and blade shaped.

Figure 11: A) Plant profile of *Ceratophyllum demersum*, common name; Coontail. B) Plant profile of *Najas guadalupensis*, common name: Common Water Nymph (Southern Naiad). C) Plant profile of *Potamogeton nodosus*, common name: American Pondweed.

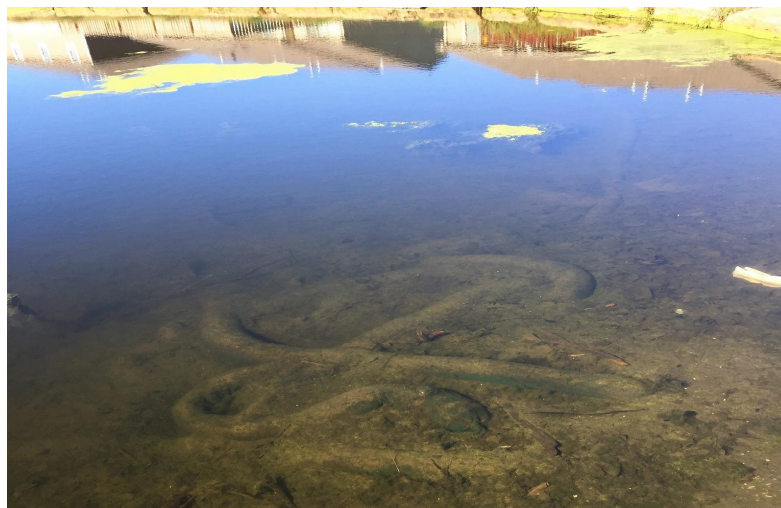
Figure 13: Poor Erosion Control

Northview Pond likely suffers from poor erosion control, which could be a major contributing factor to the observed sedimentation delineated above. An erosion sock has either washed in from the bank, or been discarded in the pond and is shown in Figure 13. Erosion socks are typically made from mesh cloth and filled with wood mulch. They are placed on a slope to trap sediment while allowing water to pass through. The section shown in the Figure 13 below is 8 to 10 inches in diameter and would measure over 80' in length.

Figure 13 shows an erosion sock that sits at the bottom of Northview Pond.

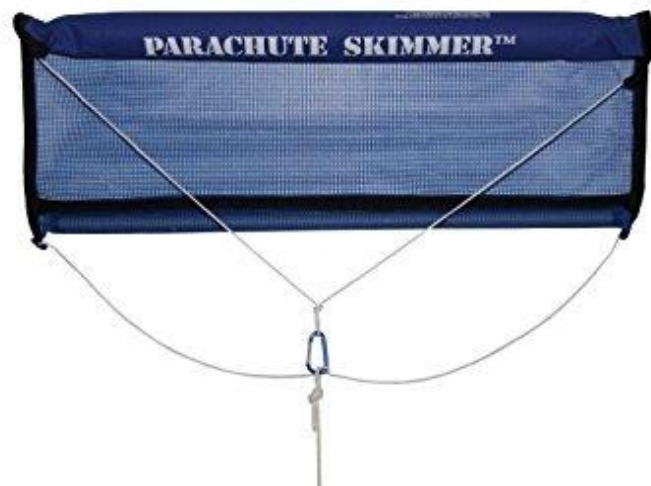
Figure 16: Parachute Skimmer

Figure 16: The Parachute Skimmer™ is meant to skim the surface of a water body or pool (*The Parachute Skimmer*, 2015)

Manually dragging the skimmer's five-foot-wide head across the pond's surface gathers and catches floating algae, dead leaves, and duckweed into its net. Various sizes are available depending on pond size. This would be a relatively cheap investment, with retail prices at maximum of \$150 (Solitude Lake Management, 2010). However, it does require repetitive manual labor since during summer seasons duckweed can proliferate again within a few weeks, if nutrient sources are still available (Lembi, 2009). Net hole size would also be important to consider, since some duckweed is very small, and may risk slipping with the net. There are numerous ways to construct collection nets or floating filtration systems to skim pond surfaces with simple materials as well.
