Environmental Assessment of K-State Campus Creek

This study of Campus Creek is completed, in part, to meet the requirements of the Natural Resources and Environmental Sciences senior capstone project at Kansas State University. The lead instructor for the course and director of the NRES Secondary Major is Dr. J.M. Shawn Hutchinson and the project team advisor is Dr. Aleksey Sheshukov from the department of Biological and Agricultural Engineering.

5/12/2017

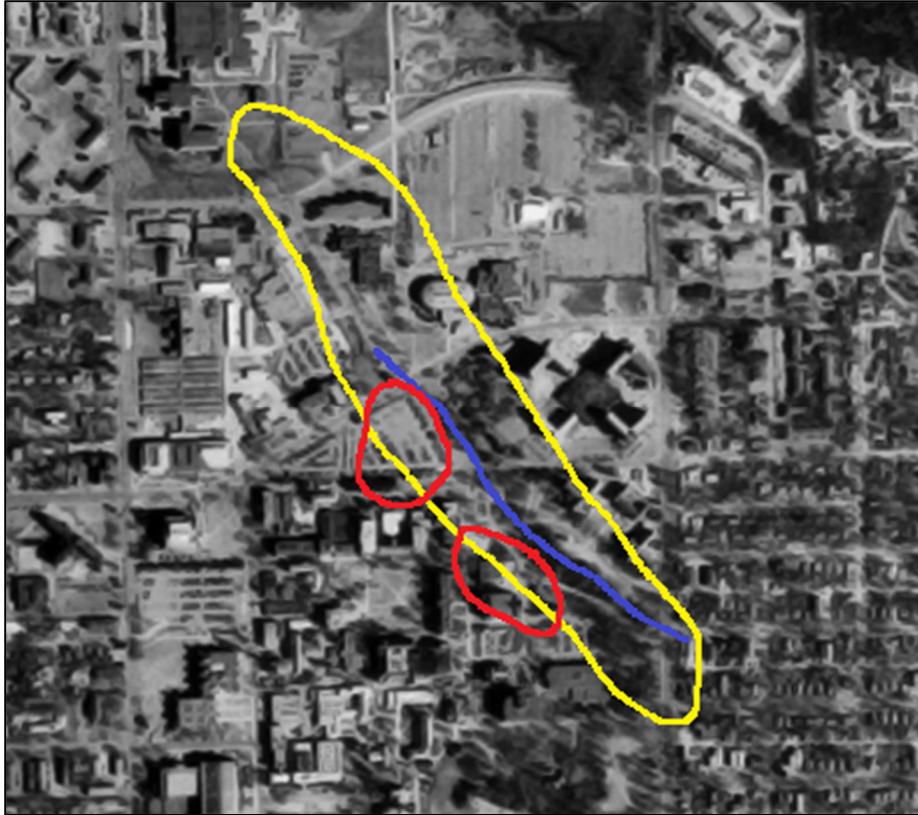
Figure 2.1: Satellite image of Campus Creek areas in 1996. (Campus Creek outlined in yellow, open land in red, and creek channel in blue)

Figure 2.1 was acquired from the USGS Imagery website and is from the year 1996. **Figure 2.2** was acquired from Google Earth and is from 2016. If you compare the two images based on the number of trees and shrubbery, in 1996 there is less coverage of trees and shrubbery. In twenty years, woody vegetation completely engulfed the creek. The yellow circles outline the creek itself. The blue lines indicate where the creek runs. The red circles show the addition of new buildings constructed within that twenty-year span alongside the creek.

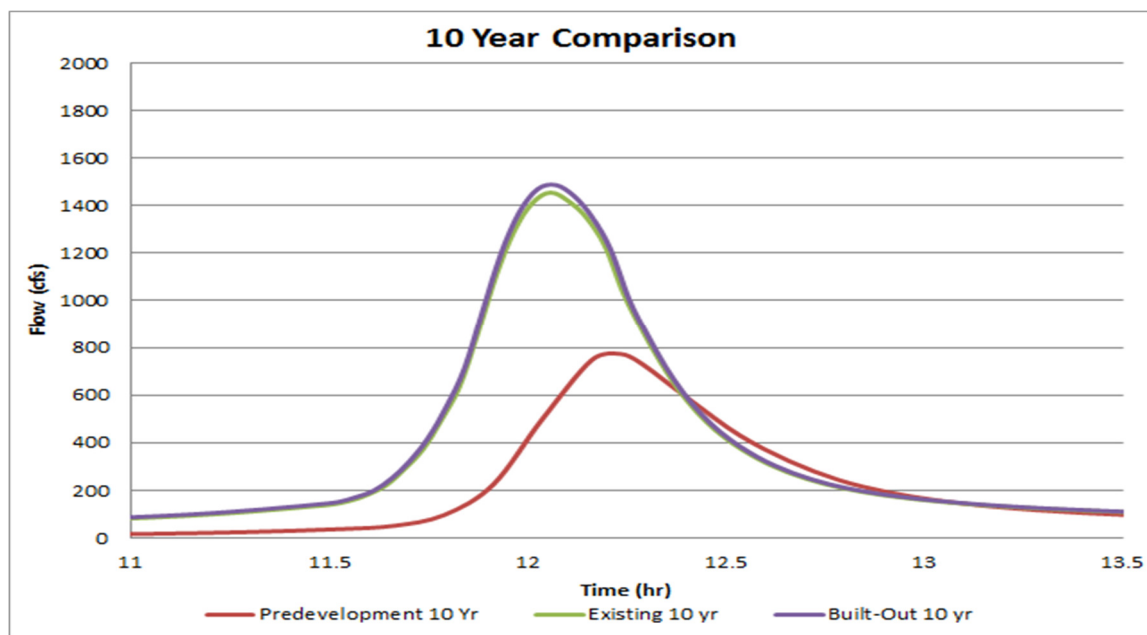
Figure 3.3: Hydrographs for the three land cover scenarios with 10 year storm events

The WinTR-55 output data from the three different land cover conditions yielded peak flow and peak time for two-three 24 hour storm return periods. A 100 year, 24 hour storm event could not be modeled using WinTR-55 as it exceeded the fundamental requirements for the structures. A 100 year return period storm was still ran for predevelopment land cover conditions to provide an interesting comparison to existing and built-out conditions. All results for peak flow and peak time are listed in **Table 3.1**. Hydrographs for each scenario are compared to each other in **Figures 3.3 & 3.4**.

As is shown in the table and hydrographs above, the development of Kansas State University's Manhattan campus has significantly increased the peak runoff for the Campus Creek Watershed. The peak runoff for a 10 yr - 24 hr rainfall event has increased by almost 100% from pre development to current conditions and by 50% for a 50 yr - 24 hr event. The continued development of the watershed will further increase the peak runoff by 2-3%, indicating that the area is nearing the maximum peak runoff potential for the watershed. This can be seen in the aerial images of the region from the Land Use section above that show a landscape with very high percentages of impervious surface area in the form of parking lots and building roof tops. These surfaces do not allow water to infiltrate into the soil and have a much lower friction coefficient which is the reason why they contribute greatly to an increase in peak discharge for small watersheds such as Campus Creek.

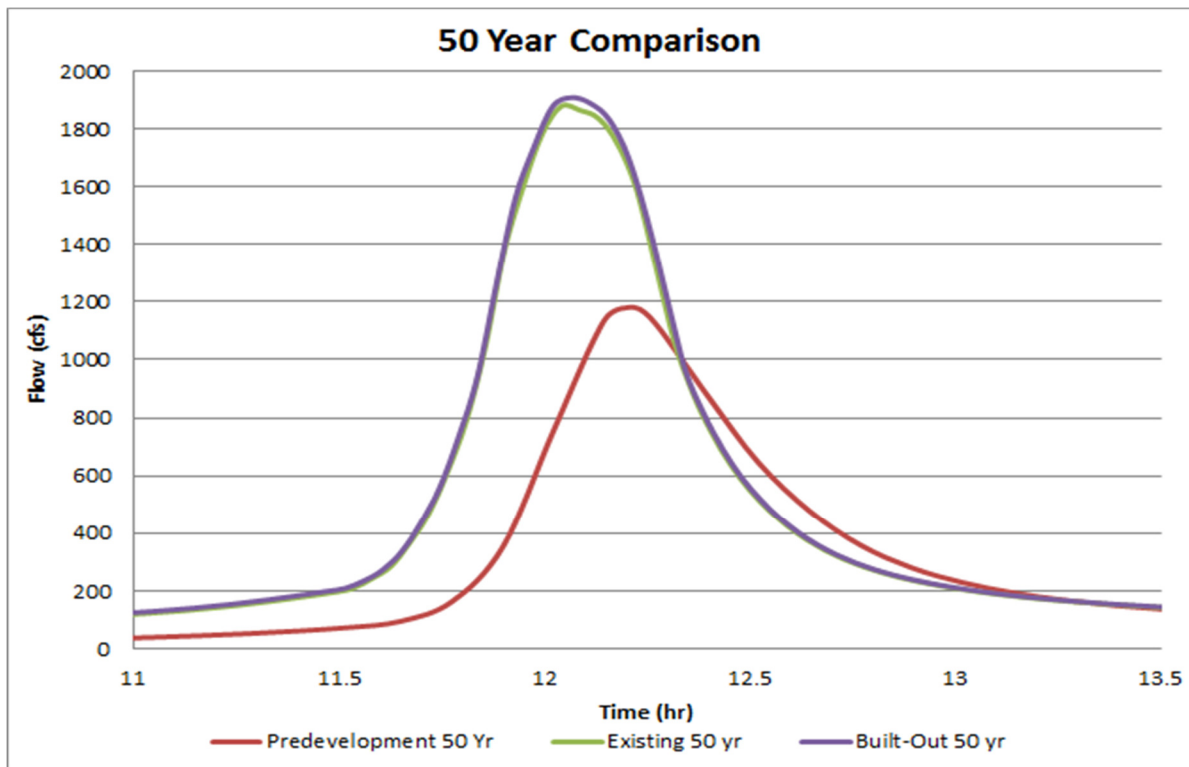
Figure 3.4: Hydrographs for the three land cover scenarios with 50 year storm events

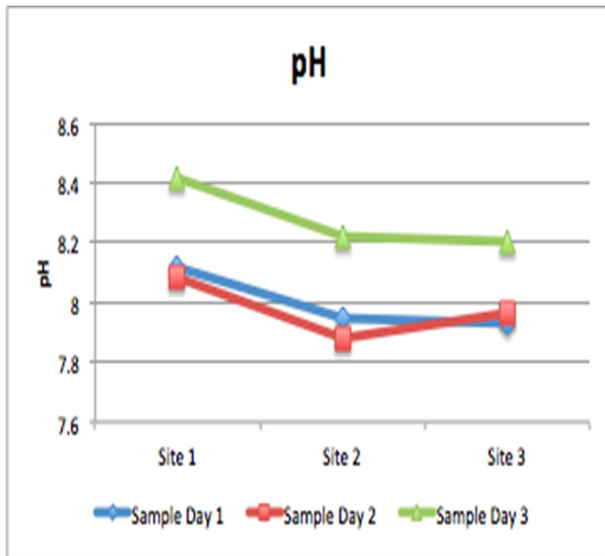
Figure 3.6: pH levels

Analysis of water quality showed several trends as the stream progressed. From location 1 to location 3, pH decreased and conductivity increased on all sample dates (**Figure 3.6 & 3.7**). This indicates the water is becoming more acidic and that more ions are present as the stream travels from Claflin Road to the edge of K-State's campus. This effect could be due to increased organic matter, however it is most likely due to contaminants entering from roadways and rooftops. Although the water is becoming more acidic, the average pH was 8.08 indicating the creek meets the EPA's pH freshwater guidelines of between 6.5-9 (National recommended water quality criteria - aquatic life criteria table).

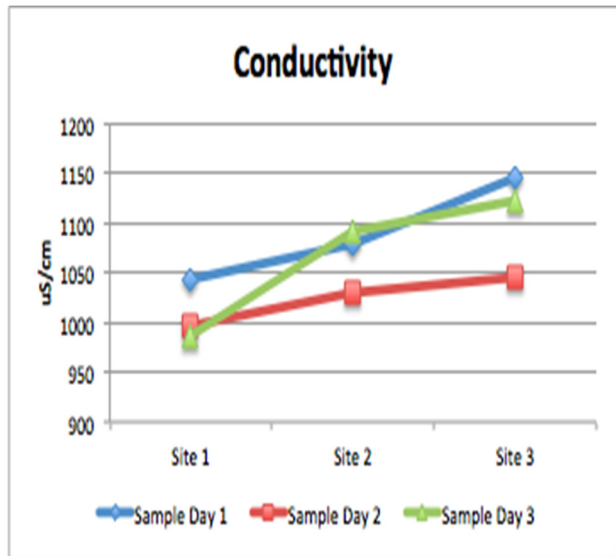
Figure 3.7: Conductivity levels

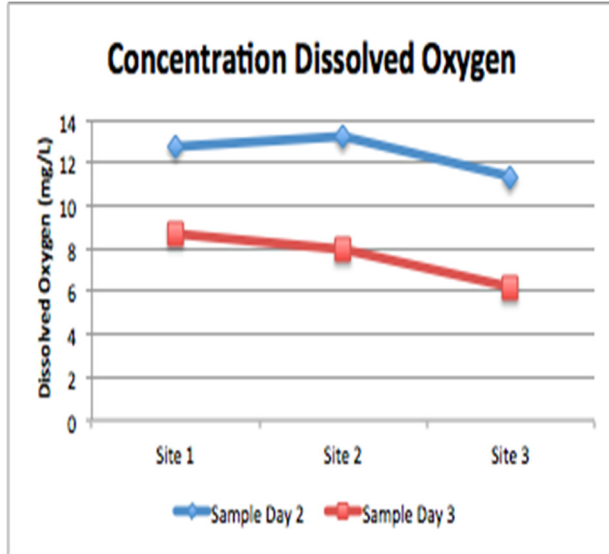
Figure 3.10: Concentration of Dissolved Oxygen (DO)

In addition to pH, conductivity, turbidity, and total solids, dissolved oxygen was also assessed. Results showed oxygen levels met freshwater biological standards and could support fish, macro and macroinvertebrates (National recommended water quality criteria - aquatic life

criteria). Dissolved oxygen data from sample day 1 was excluded because the sampling containers may have influenced results (**Figure 3.10**).
