Natural Resources and Environmental Sciences Capstone Course

April 24, 2018

Marion County Park and Lake Sediment and Water Quality Study

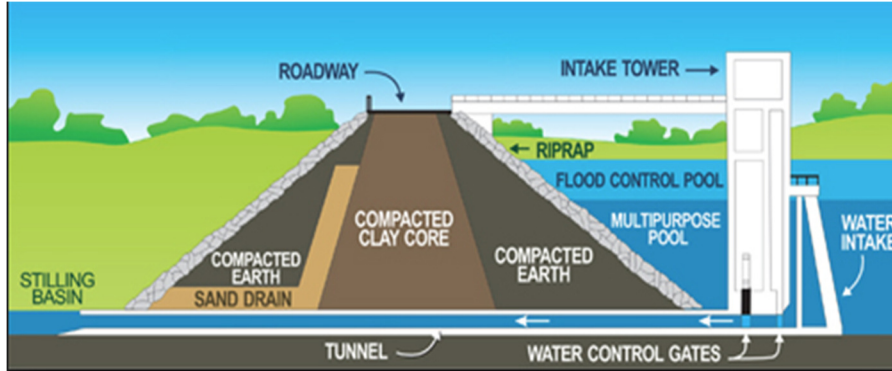
Figure 8: Bottom Controlled Reservoir Outlet Structure (Osage County, 2018)

One unique feature of Marion County Park and Lake is the outlet structure. Marion County Park and Lake is a normally ponded reservoir, which means the water is released from the surface of the lake. This is very similar to many smaller ponds with a spillway design, while many larger bodies of water release water from the bottom of the reservoir. This is important to note, as during periods of drought when the water level is low, there is no outflow from normally ponded reservoirs. This type of outlet structure also creates a lack in the ability to manage the system properly. Reservoirs with bottom-controlled outlets can put into place management strategies such as sediment flushing to ease the burden of sediments on the reservoir, thus extending the life. Normally ponded reservoirs have longer retention times and higher trapping efficiencies when compared to traditional reservoirs, which cause an increase in sediment retention.

During dry periods when there is no outflow from the outlet structure, the trapping efficiency is 100% and the retention time is indefinite. Marion County was experiencing drought conditions when samples were collected on 4/10/2018, causing the lake water level to be 2.1 ft. below the outlet elevation. These measurements were gathered using a laser and measuring rod. Survey data can be found in Appendix B. This indicates that all water flowing into the reservoir will be held there until the water level raises to the outlet's elevation. This is a common occurrence for other normally ponded reservoirs in the same geographic region, which usually face these conditions during droughts or the summer months when there is little rainfall and high evaporation rates. The differences between outlet structure types can be observed in Figures 8 & 9.

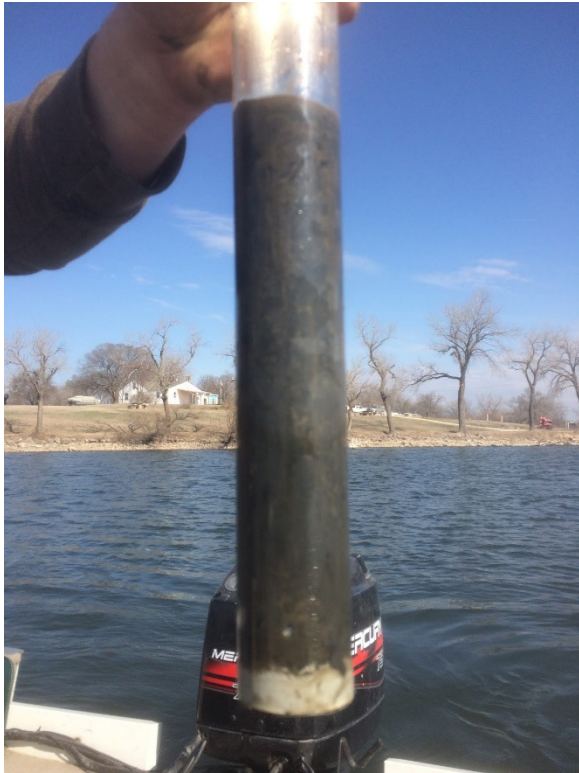
Figure 14: Marion County Sediment Core-Sample (Site #9)

Team members collected sediment samples with a gravimetric sediment sampler. The sediment sampler is a long metal tube that penetrates the surface sediment when released from the boat, bringing back a sediment core when retrieved. A sediment core is not representative of the total sediment depth at the sample location, but rather offers insight into the amount of surface sediments. Figure 14 and 15 show sediment cores taken at Site #9 and 8, respectively, on the day of sampling. The depths of surface sediments throughout the collected areas are denoted in Appendix A. Appendix B provides a detailed list of sampling and laboratory procedures used for Marion County Lake samples.

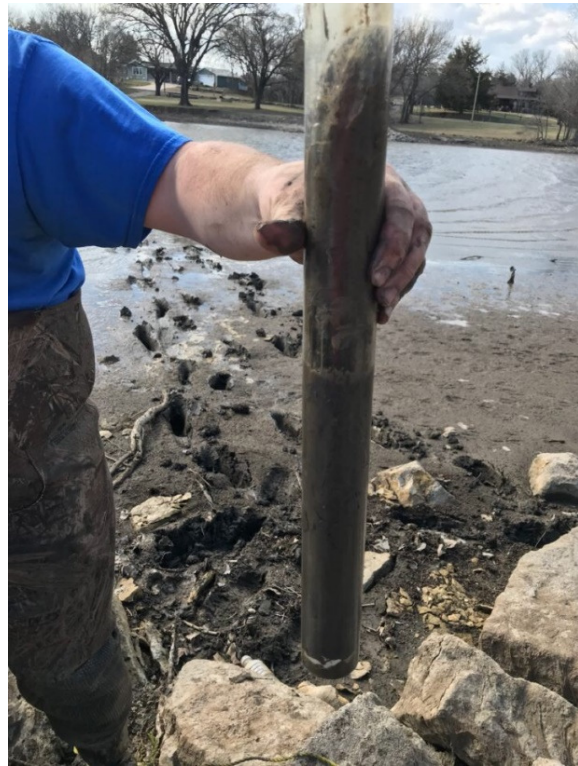
Figure 15: Marion County Sediment Core-Sample (Site #8)

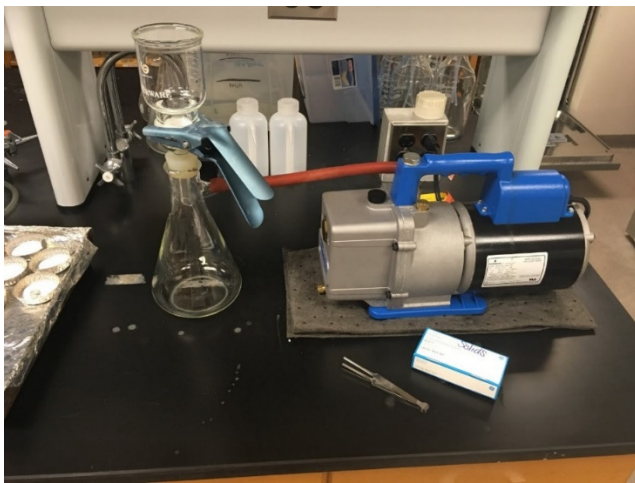
Figure 22: Suction Pump Used for Solids Filtration

These sample sites are also located in the erosional section of the lake, which is where a large amount of sediments are re-suspended. Figures 22 and 23 below show the suction pump used to filter sediments through the filter paper, and all the dishes with filter paper after filtering, respectively. In Figure 21, one sample is noticeably darker than the rest, Sample #8. This gives a representation of how much more sediment was in Sample #8 compared to the other samples.

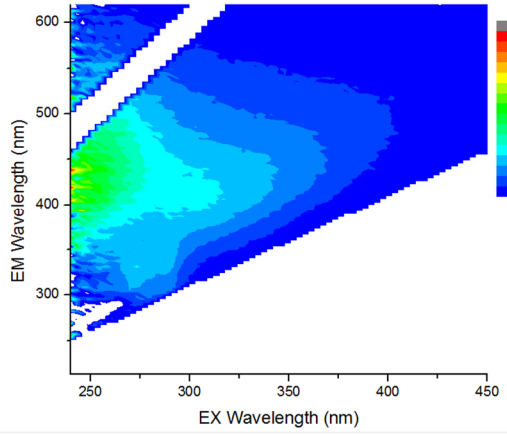
Figure 28: Marion County Sample 1 EEM Plot

Two samples of lake water were taken from Site #3a was analyzed through a fluorometer. The fluorometer produced an excitation emission matrices (EEM) of the sample water, offering insight into the composition of the sample. Varying particles fluoresce at different wavelengths, allowing the fluorometer to determine what is in the samples. The particles are plotted on an excitation wavelength vs. emission wavelength plot to allow for visual interpretation of water quality. Figures 28 and 29 show these plots for both samples taken from Site #3a. A Mat Lab code can be written to compare the results to indices to pin-point what exactly is in the water. Due to errors in analyzing the data, the chlorophyll samples have not yet been compared to indices to determine what is in the samples. The protocol for analyzing data is outlined in Appendix B. Raw data can be obtained from team members upon request.

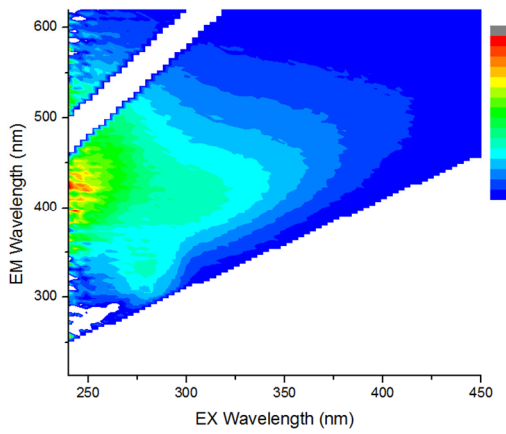
Figure 29: Marion County Sample 2 EEM Plot

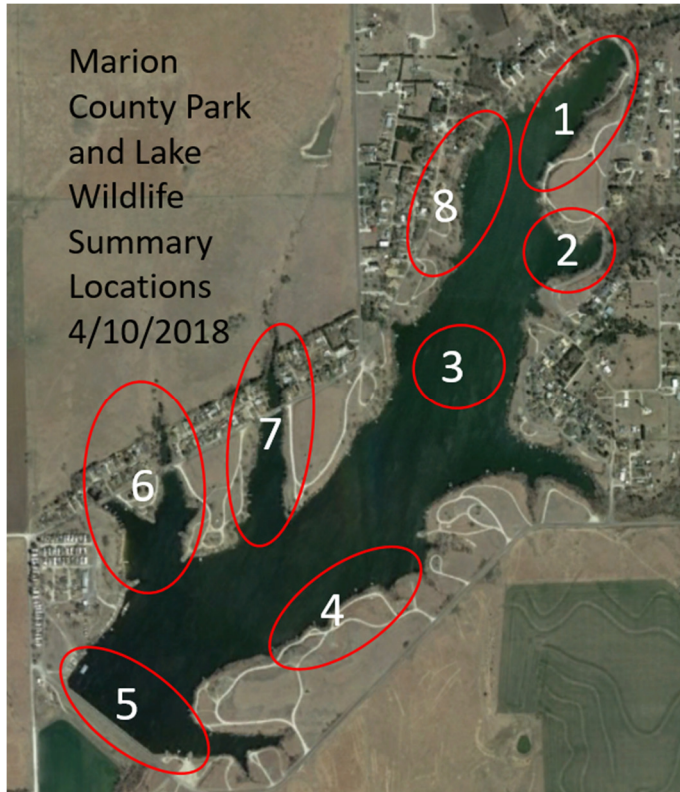
Figure 31: Map of Wildlife Summary Locations – Marion County

On the evening of 4/10/2018, a vehicular survey of all wildlife around the lake was surveyed, beginning at 5:30 p.m. Team members observed all areas around the lake, denoting wildlife activity, which is outlined in Table 5 below. The locations of observed wildlife can be seen in Figure 31.

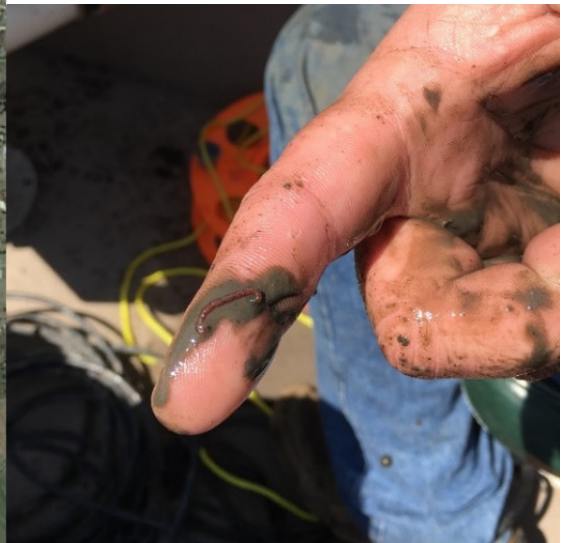
Figure 32: Midge Larvae- Marion County Site #3d

It is also important to note that midge larvae were observed in sediment sample cores at Sites #2b, 3d, 5e, 7e, and 9b. Midge larvae are an important part of the diet of select fish, such as trout. Finding midge larvae in core samples throughout the lake suggest their presence throughout the entirety of the lake bottom. An image of one of the collected midge larvae is attached above, in Figure 32.
