# Marion County Lake Shoreline Buffer Zone Health Assessment through Computational and Chemical Analysis

This study of Marion County Lake was completed as a capstone project with Dr. Aleksey Sheshukov from the department of Biological and Agricultural Engineering as the faculty advisor with support from Dr. Shawn Hutchinson as the lead instructor and director of the Natural Resources and Environmental Science Secondary Major.

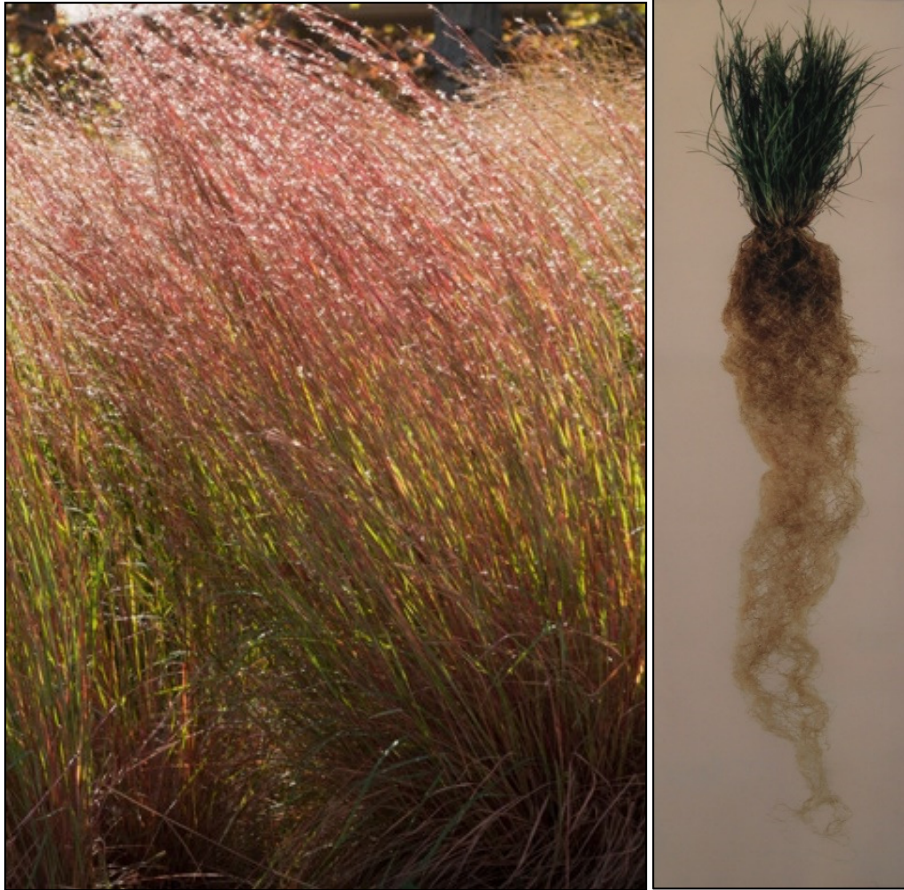
***Figure 1. Little Bluestem Stalk and Root Character***

<b>Scientific name:</b>	Schizachyrium scoparium
<b>Grass Family:</b>	Poaceae
<b>Flowers:</b>	July - September
<b>Height:</b>	2 - 4 feet
<b>Roots:</b>	4.5-5.5 feet, dense, fibrous
<b>Management:</b>	Fire / Cutting

As a result, there are a variety of different grasses that could be planted along the shoreline of Marion County Lake. Both big bluestem and little bluestem have a dense and deep root system that would add great retention and stabilization qualities to the shoreline. Big bluestem has a unique “turkey foot”-shaped seed panicle and little bluestem grass is considered to be ornamental, providing a nice aesthetic quality to the lake environment. Switchgrass is another viable grass as its root system can reach great depths, making for a great shoreline plant that offers stability. The open panicle of switchgrass gives a unique ornamental quality. Barnyard grass would be a great species to have because its shallow, dense root system would increase shoreline stability and help protect early establishment of deeper root systems against erosion. There are also many large seeds that will be produced by barnyard grass, providing a notable food source for wildlife. Indian grass would offer stability as well to the soil with its deep, dense roots, but its gold seeds and tiny yellow flowers in late summer would provide beautiful scenery for the lake. The seeds from Indian grass are also great food sources for many animals and the grass provides shelter opportunities for riparian animals as well. Purple top would add a great late season splash of color to the shoreline with its deep purple panicles. This would add a nice aesthetic value to the Marion County Lake shoreline buffer zone. The seeds are also enjoyed by many animals as well. The wide root system will help bind other grass roots together and increase stability.

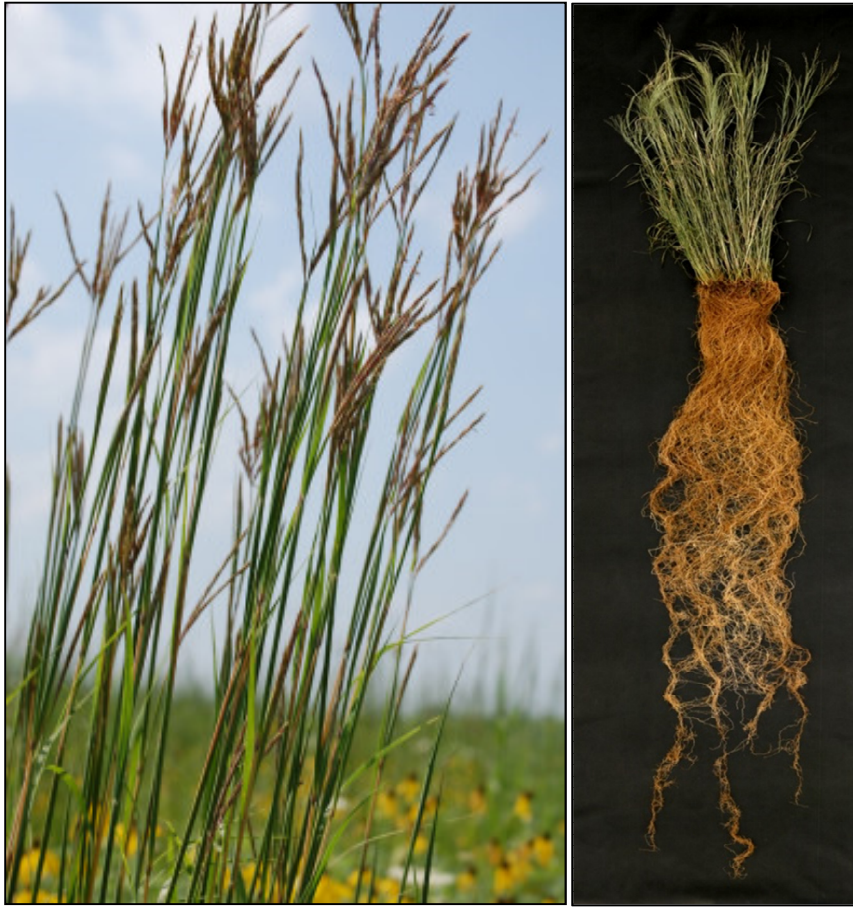
*Figure 2. Big Bluestem Stalk and Root Character*

<b>Scientific name:</b>	Andropogon gerardii
<b>Grass Family:</b>	Poaceae
<b>Flowers:</b>	July - September
<b>Height:</b>	2 - 7 feet
<b>Roots:</b>	7-8 feet, dense, fibrous
<b>Management:</b>	Fire / Cutting

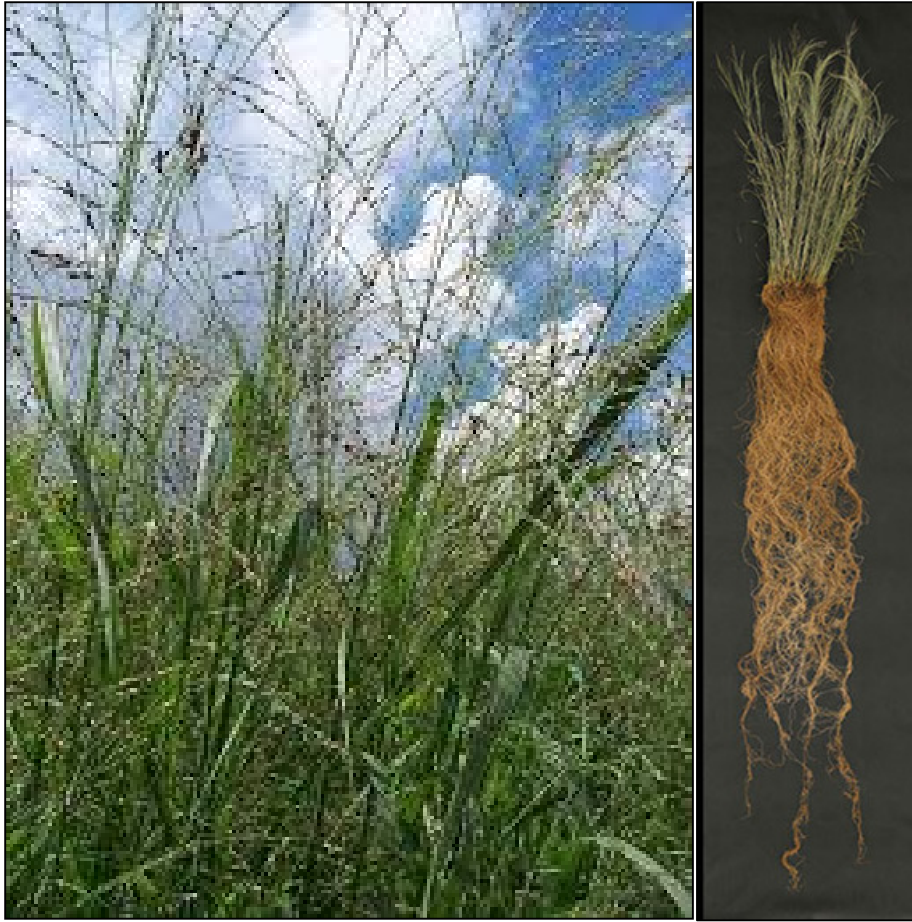
*Figure 3. Switchgrass Stalk and Root Character*

<b>Scientific name:</b>	Panicum virgatum
<b>Grass Family:</b>	Poaceae
<b>Flowers:</b>	August - September
<b>Height:</b>	2-7 feet
<b>Roots:</b>	Dense top 12in, 10ft max depth, dense throughout
<b>Management:</b>	Fire / Cutting

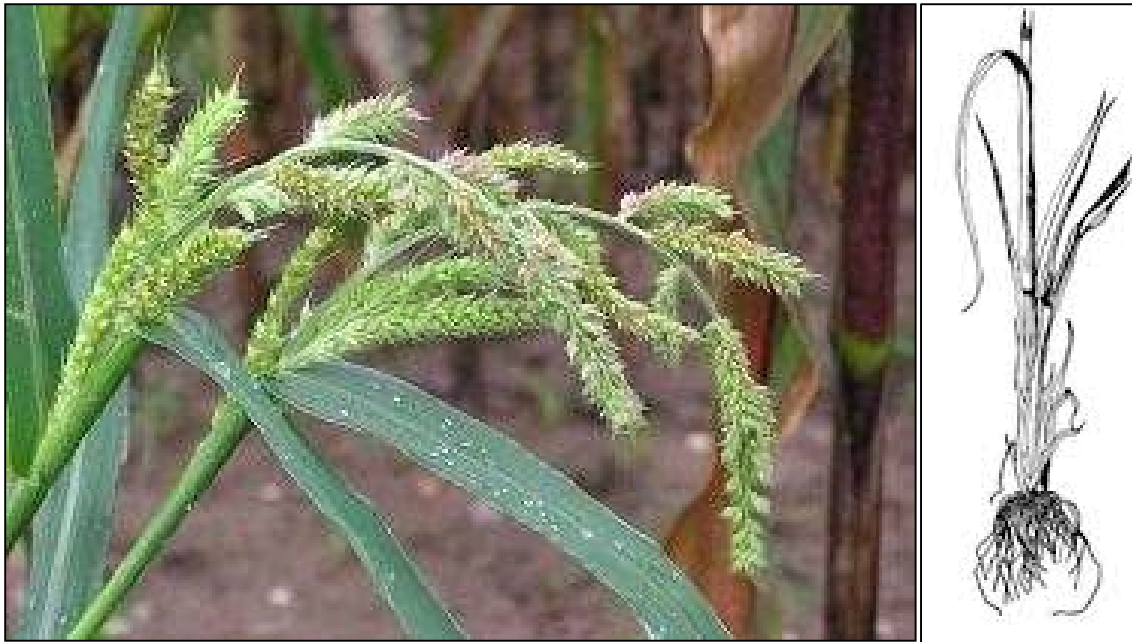
*Figure 4. Barnyard Grass Stalk and Root Character*

<b>Scientific name:</b>	Echinochloa muricete
<b>Grass Family:</b>	Poaceae
<b>Flowers:</b>	July - September
<b>Height:</b>	1 - 5 feet
<b>Roots:</b>	Shallow, dense, thick stalks
<b>Management:</b>	Fire / Cutting

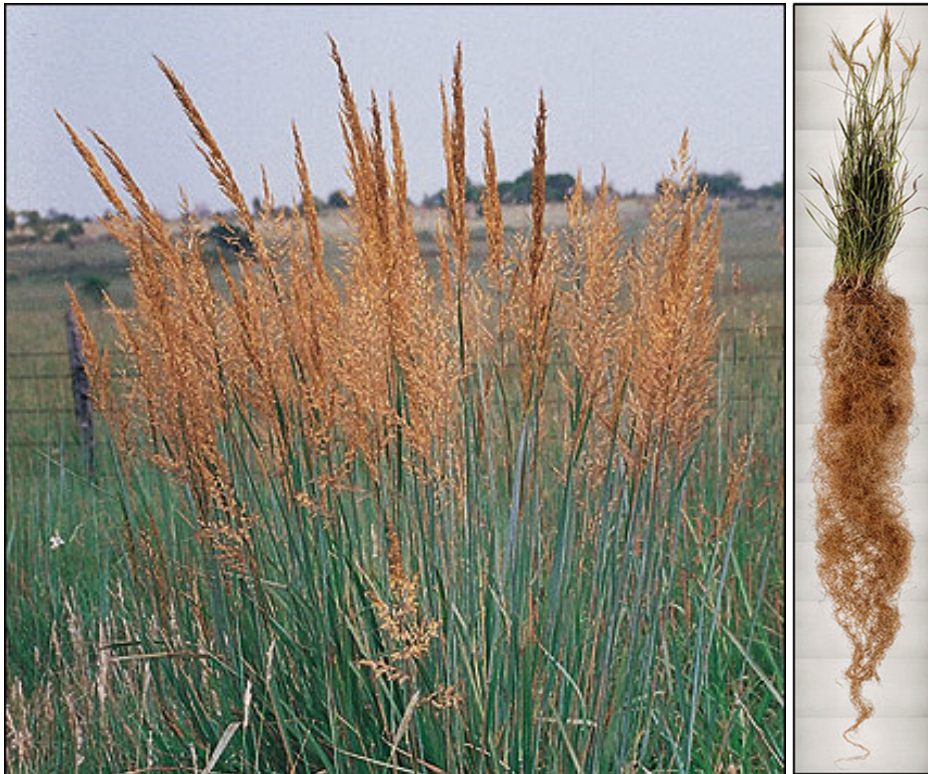
*Figure 5. Indian Grass Stalk and Root Character*

<b>Scientific name:</b>	Sorghastrum nutans
<b>Grass Family:</b>	Poaceae
<b>Flowers:</b>	July - September
<b>Height:</b>	3 - 7 feet
<b>Roots:</b>	6 feet, dense, fibrous
<b>Management:</b>	Fire / Cutting

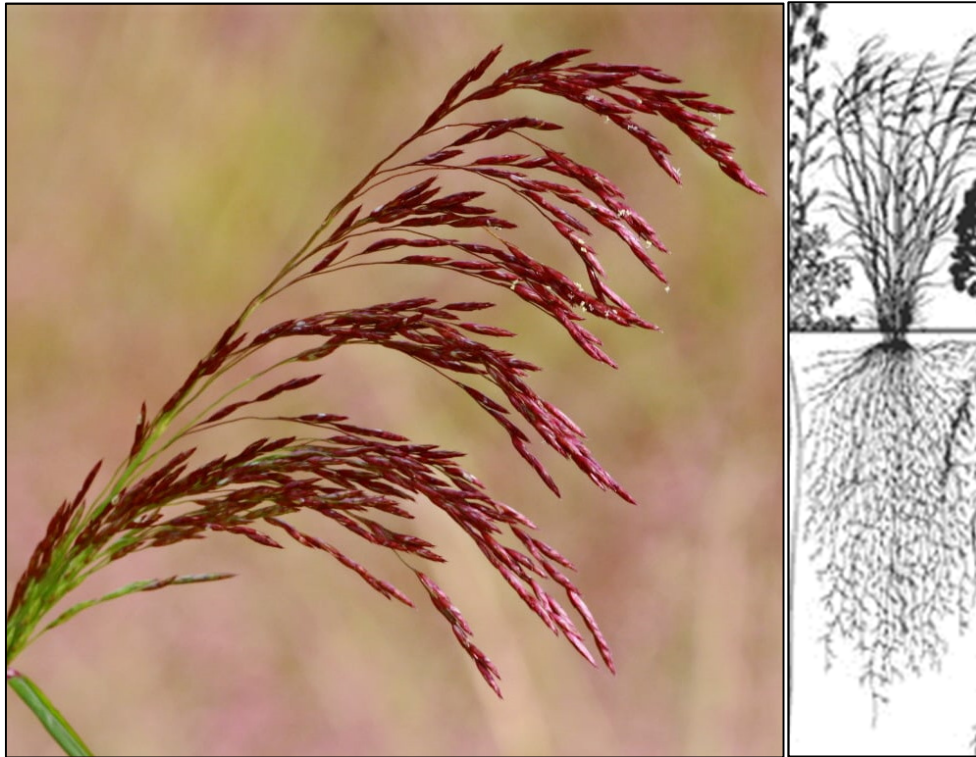
*Figure 6. Purple Top Stalk and Root Character*

<b>Scientific name:</b>	Tridens flavus
<b>Grass Family:</b>	Poaceae
<b>Flowers:</b>	July - September
<b>Height:</b>	2 - 5 feet
<b>Roots:</b>	1 - 3 feet wide
<b>Management:</b>	Fire / Cutting
