**Assessing the Impact of Anthropogenic Habitat  
Fragmentation and Area Downsizing on the Environmental  
Functionality of Marion County Lake and Park.**

**To:** Shawn Hutchinson and the Marion County Park and Lake Officials

**Date:** 05/07/2020

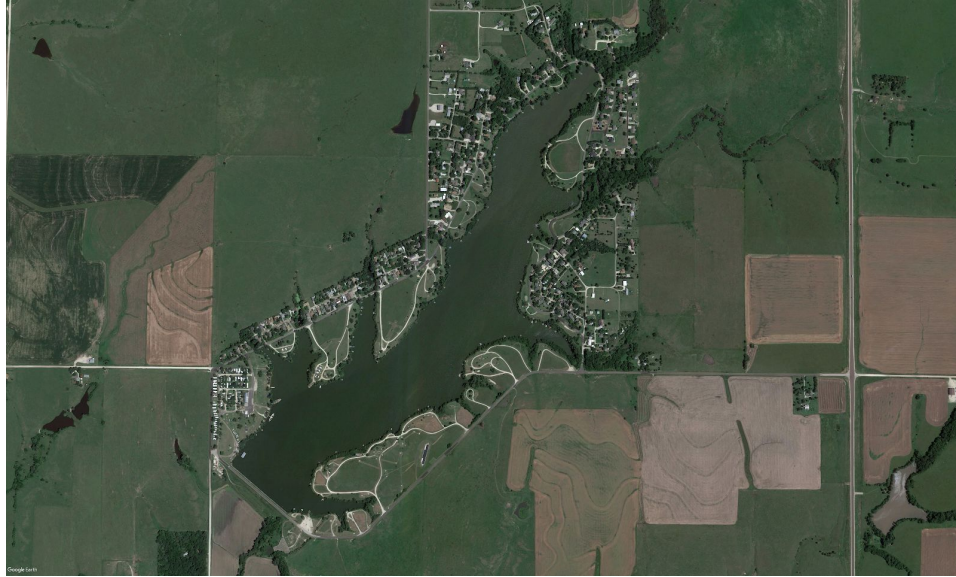
**Figure 3.** Aerial image of Marion County Lake and Park (Google Earth Pro).

The first step of this project consisted of quantifying the fragmented land patches within the park by labeling a high resolution satellite image with the Matlab (Mathworks, Natick, MA) Image Labeler software. There are 48 patches that were mapped for Marion County Park. The satellite image was obtained from Google Earth and had a size of  $4800 \times 2886$  pixels. Patches between roads were extracted using Matlab Quantifying changes in patch metrics over time could be a useful indicator of biodiversity changes in fragmented landscapes. Spatial attributes of patches affected by habitat loss and fragmentation over extended time-periods can use methods involving, aerial image acquisition and processing, classification of land cover classes and quantification over land cover loss, quantification of grassland fragmentation, and influence of roads on edge effects of fragmented grassland patches (Niemandt et al, 2016).

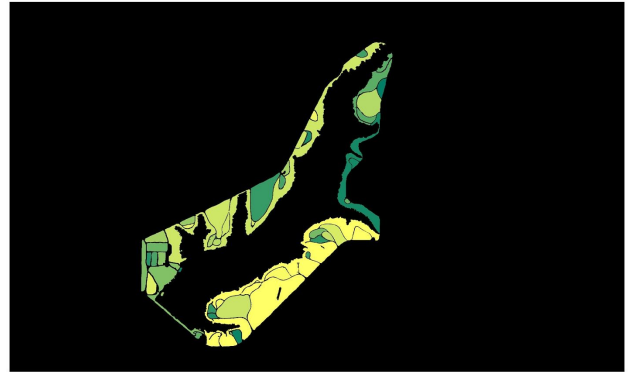
The following maps shown in Figure 4 and 5 indicate the first part of the project which included mapping the park and lake. The first two maps include the entire park boundary with the lake, with different types of land being indicated with different colors. The map coordinates from the NE corner are 38.331580, -96.962092 and 38.312289, -97.003107 in the SW corner. The map area from the North-South distance are 2140 meters, and 3600 meters from the East-West distance, totalling 7,70400 squared meters (7.7 km<sup>2</sup>). 48 different patches can be identified from the maps. The smallest patch shown is 38m<sup>2</sup> while the largest patch shown is 145300m<sup>2</sup>.

**Figure 5. and Figure 6.** Labeled Patches of Marion County Park and Lake
